Gaps and Cracks

We guarantee that our furniture will have gaps and cracks, but will not fall apart for as long as you own it!

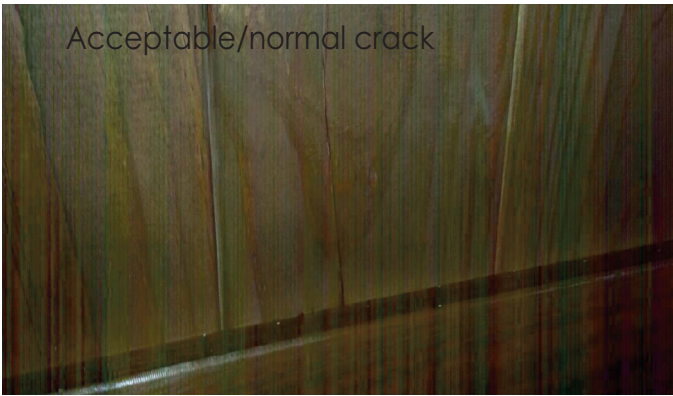
Acceptable/normal crack

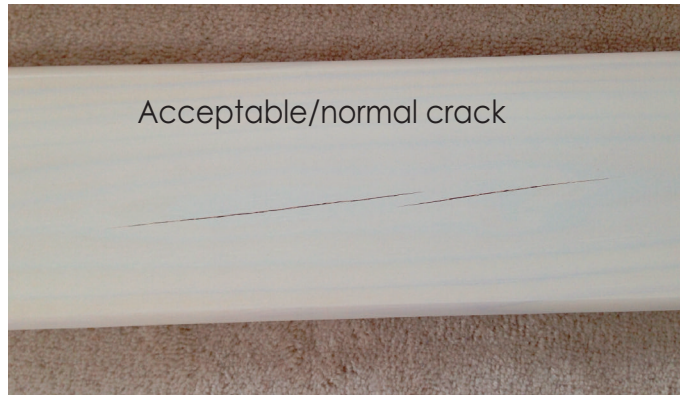
Acceptable/normal crack

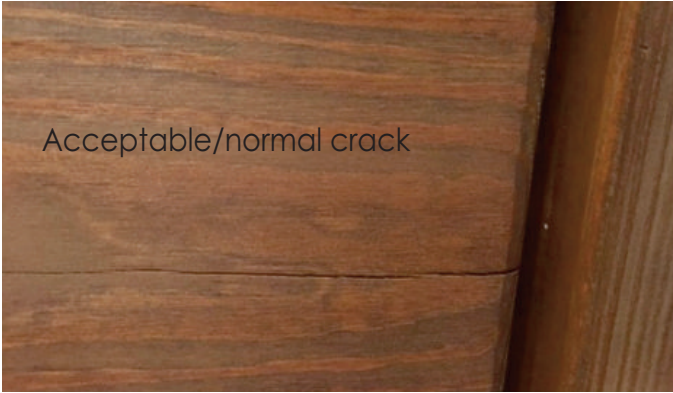
Acceptable/normal crack

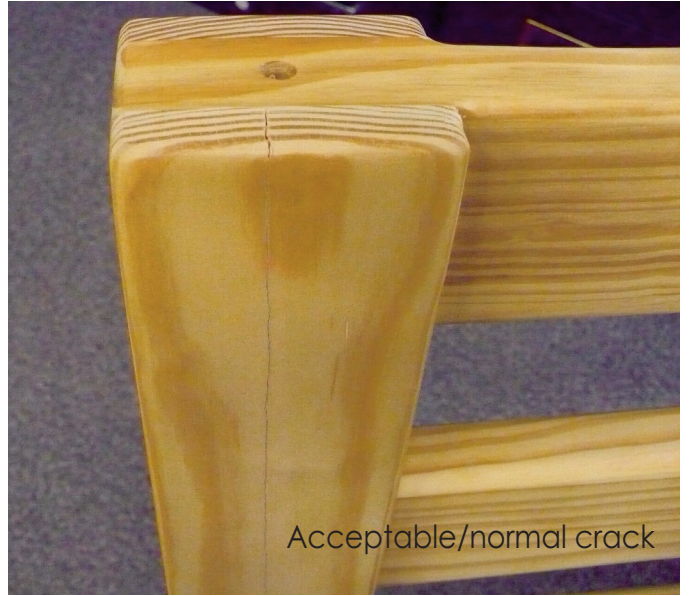
Acceptable/normal crack

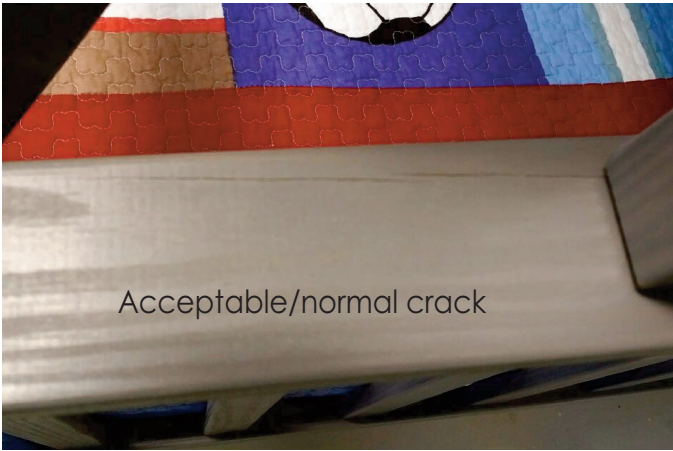
Acceptable/normal crack

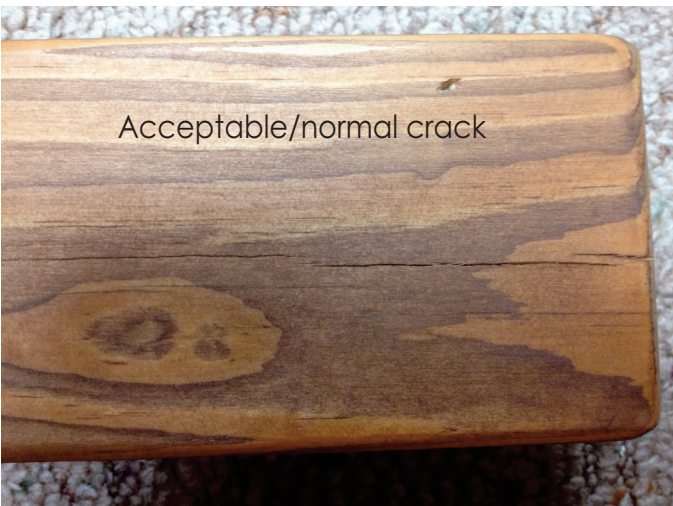
Acceptable/normal crack

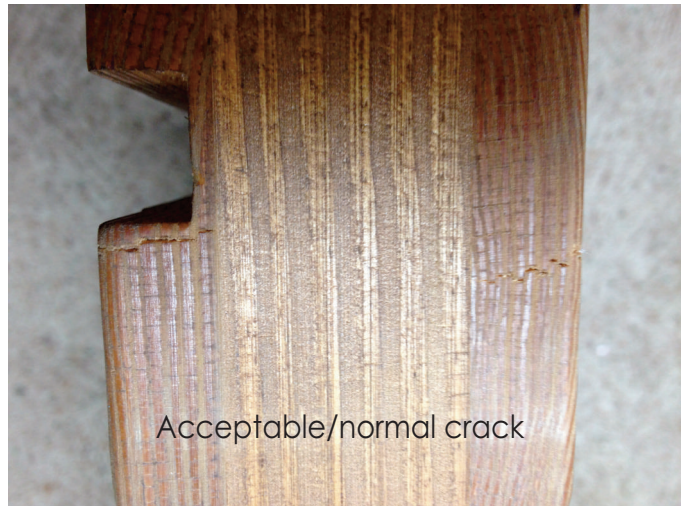
Acceptable/normal crack

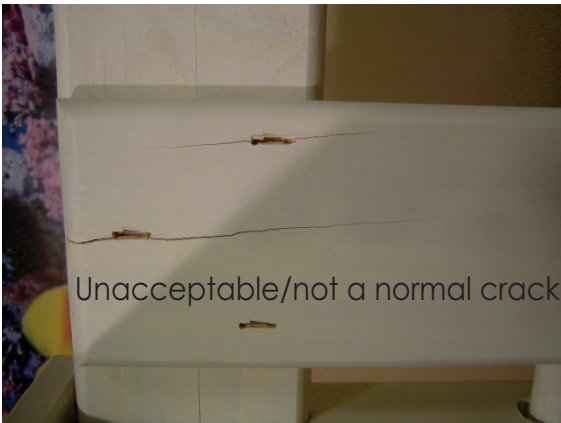
The image below shows cracks in a guardrail caused by improper stapling. This rail would be replaced.

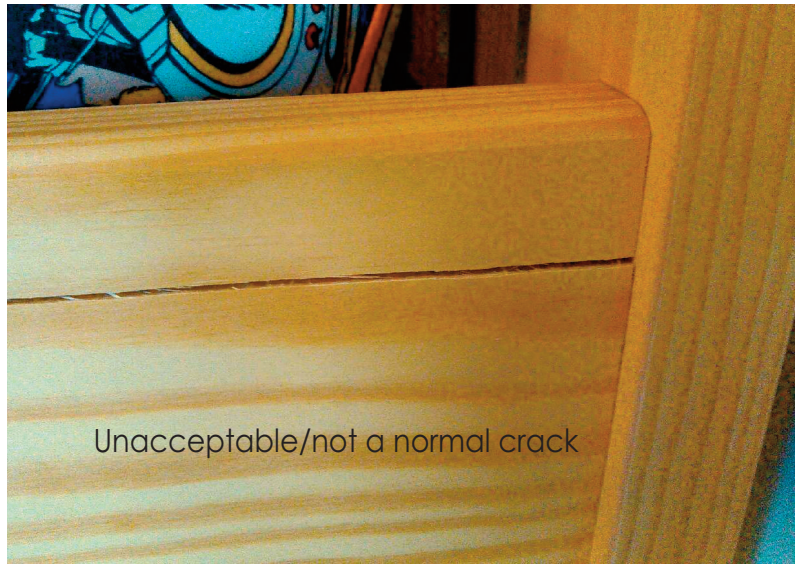
The image below shows a crack at the bolt area in the end of a bed rail. This is a potential structural issue and the bed rail would be replaced.

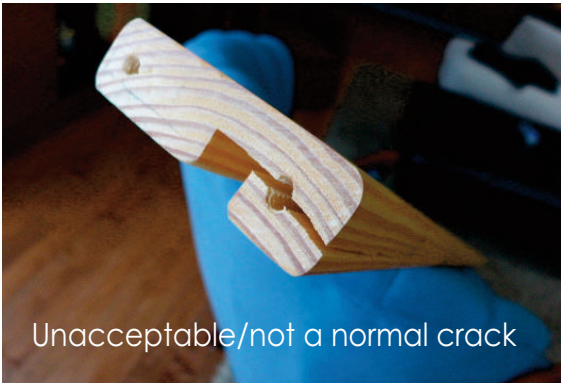
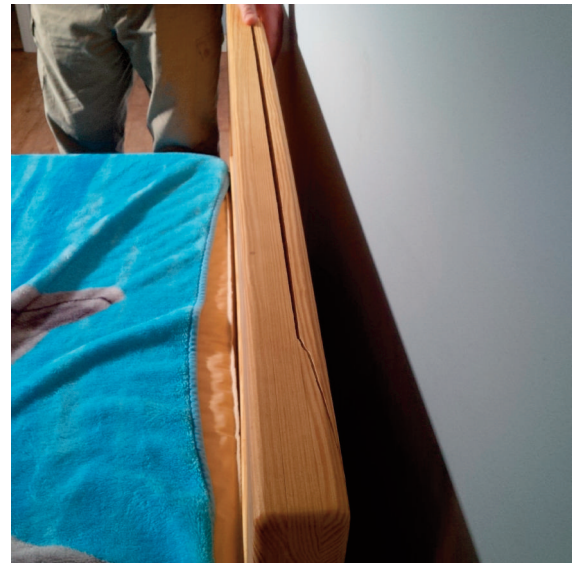
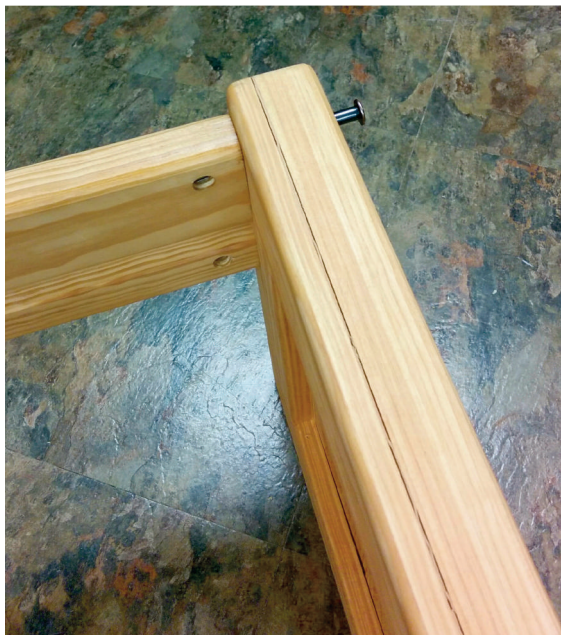
The bed ends in the image above and to the left have joint failures and would be replaced.

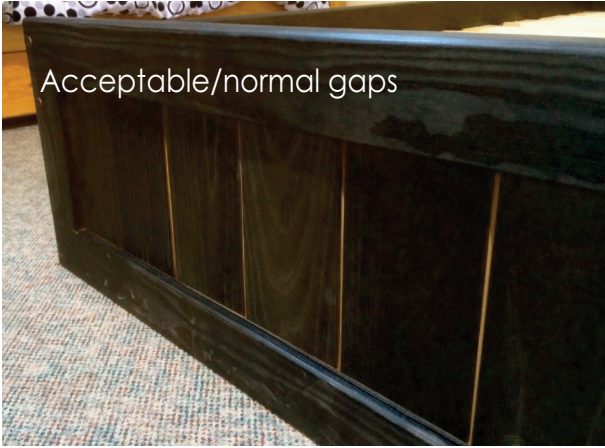
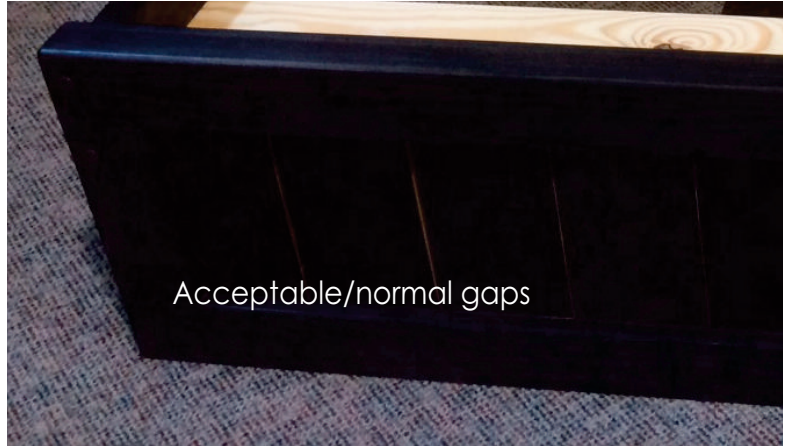
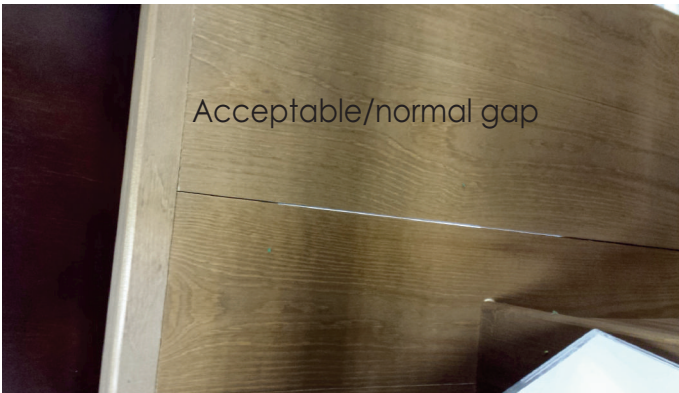
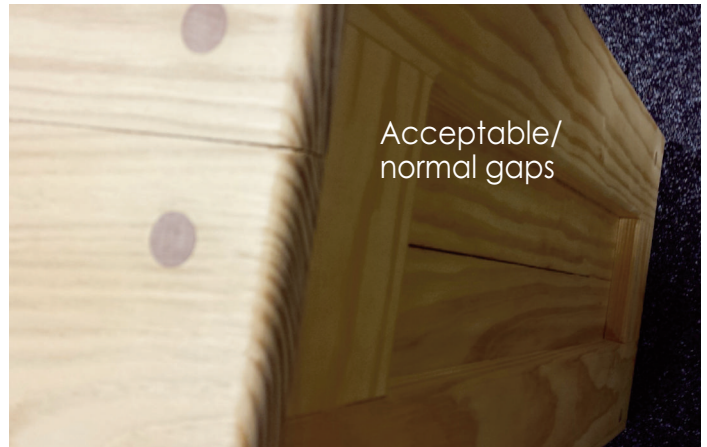
The images below illustrate the gaps that can be expected as Southern Yellow Pine shrinks as a result of drying.

While we use kiln dried lumber, it is only dried to 12% moisture content. At this level it possible that further drying will occur.

This drying will result in shrinkage. Boards that were tight together at the time of assembly may not stay that way.

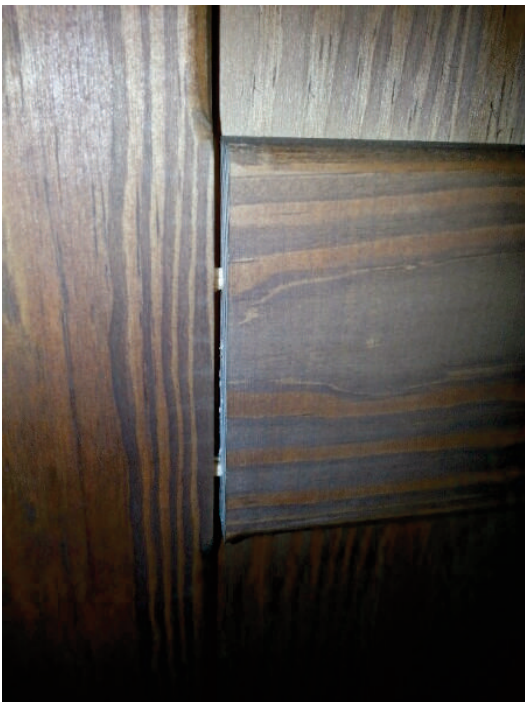
In the image to the left, the joint between 2 pieces of a gable frame has opened up. The degree of separation is unacceptable and would be replaced.
