Gaps and Cracks

We guarantee that our furniture will have gaps and cracks, but will not fall apart for as long as you own it!

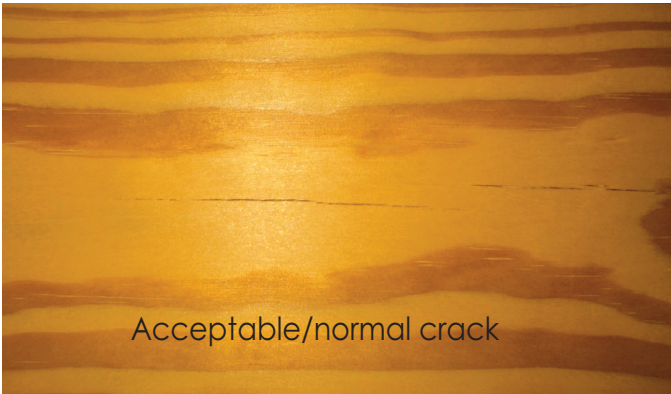
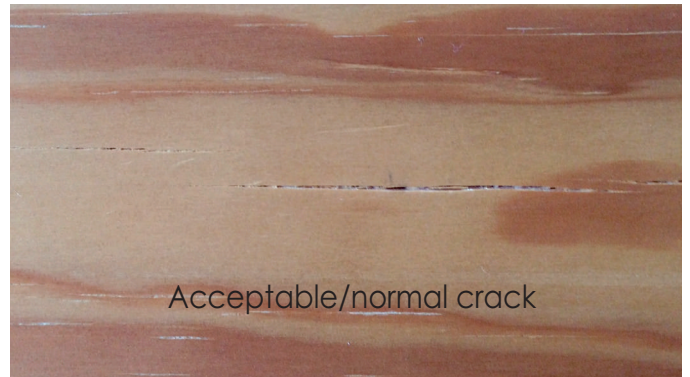
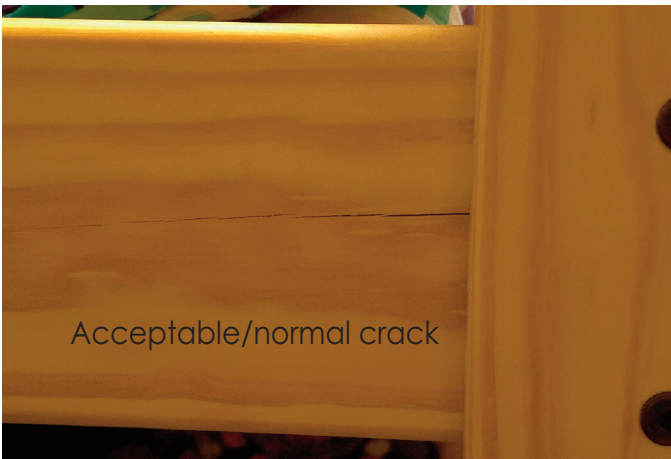
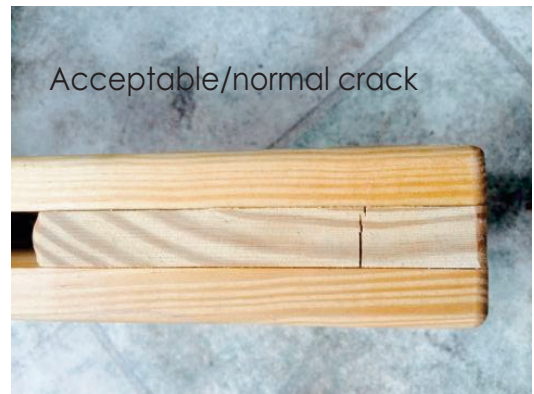
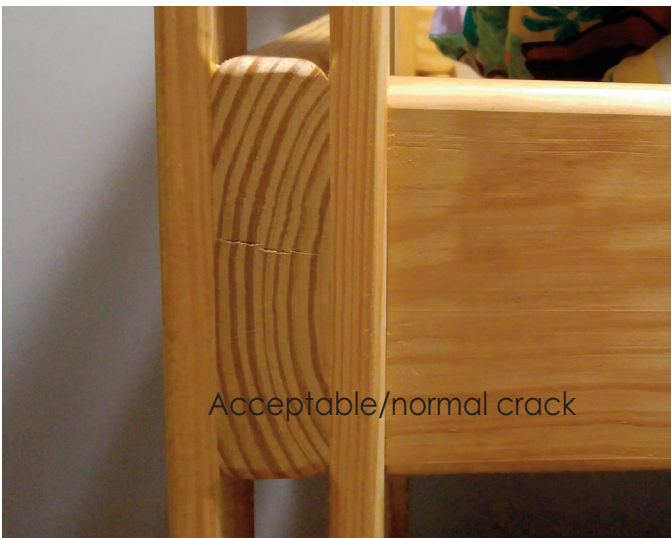
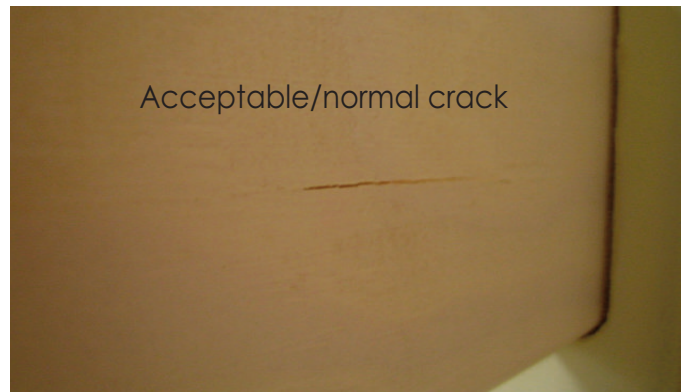
These images show the typical cracks that can be expected in Southern Yellow Pine and are considered acceptable (normal).

They will in no way affect the structural integrity of the furniture. Should a crack ever affect the servicability of a piece of furniture, the affected part will be replaced.
